Manhole Inspection Summary

Manhole # S63M__015MH

Insp Date: **5/1/08 11:54 PM**

Location Address: **5423 Interstate Ave.**

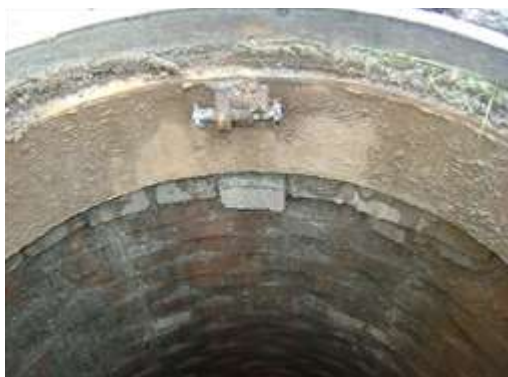
Defect 3

Condition: ☐ Sound ☐ Cracked ☐ Root Intrusion ☒ **Loose Brick** ☐ Deteriorated

Loose bricks under frame

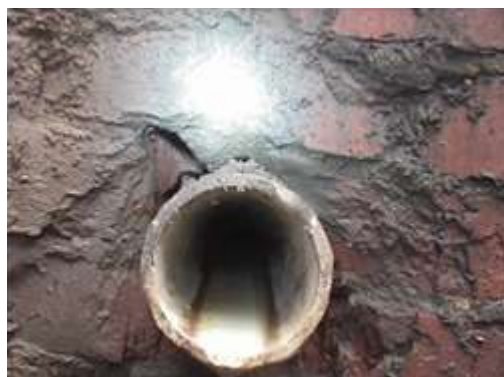
Defect 2

Cracked pipe seal 10:00-11:00 incoming 1 o'clock

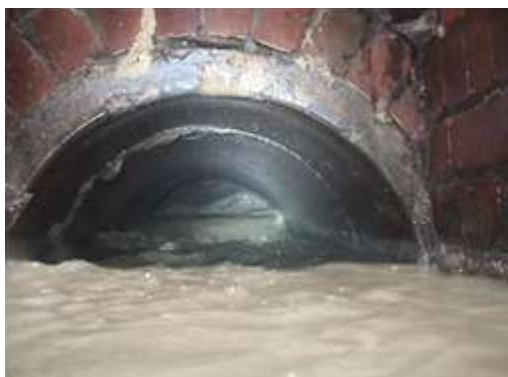
Defect 4

Cracked pipe seal 11:00-1:00 incoming 6 o'clock

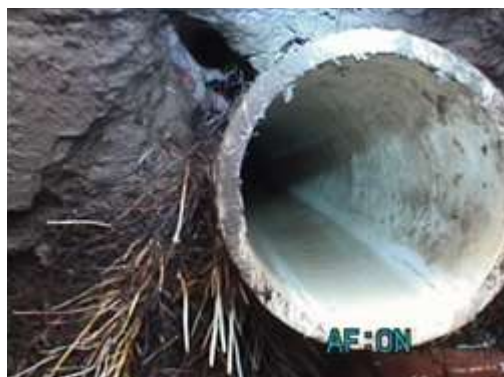
Defect 7

Roots medium 7:00-10:00 on incoming 1 o'clock. These have occurred since a prior visit.

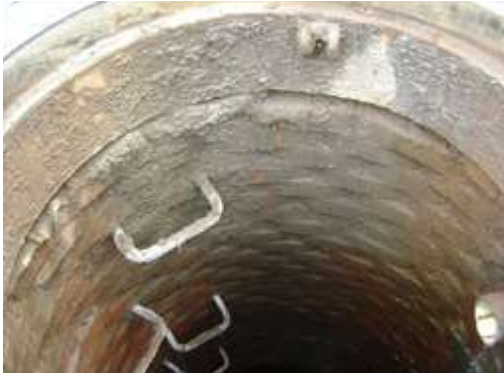
Defect 4

evidence of infiltration under manhole cover

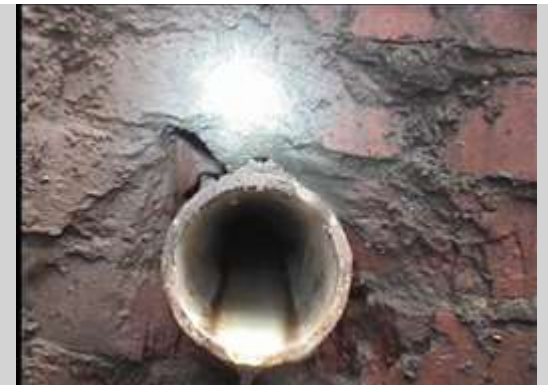
1 O'Clock Inflow

Pipe Height: **2.4** (in.) Rod Only
Pipe Material: **PVC** ☐ Pipe Lined
Invert Depth: **1.83** (ft.) Flow Characteristics: **Slow**
Deposits: ☒ None ☐ Mud ☐ Sludge ☐ Debris ☐ Grease
Silt Depth: (in.) Deposits Extent:
Infiltration: **None** Pipe Seal Cond: **Cracked**

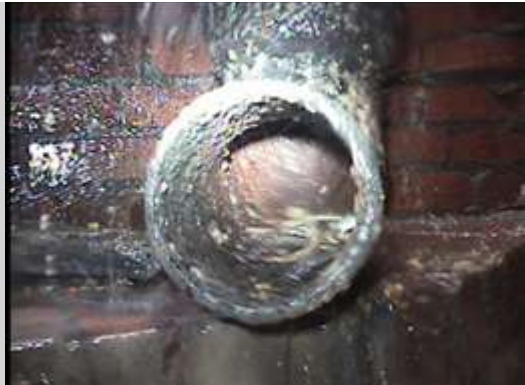
2 O'Clock Inflow

☒ Possible Illicit Connection
